FEDERAL PACIFIC PANELS

Federal Pacific (FPE) "Stab-Lok" circuit breaker panels have been identified as having inherent defects.

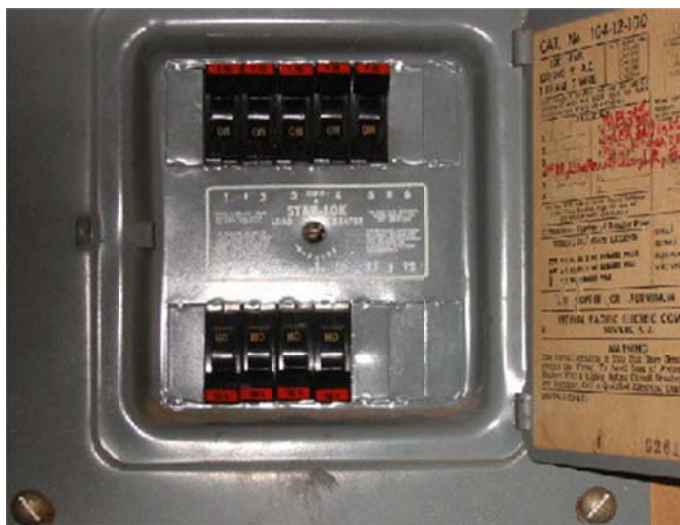
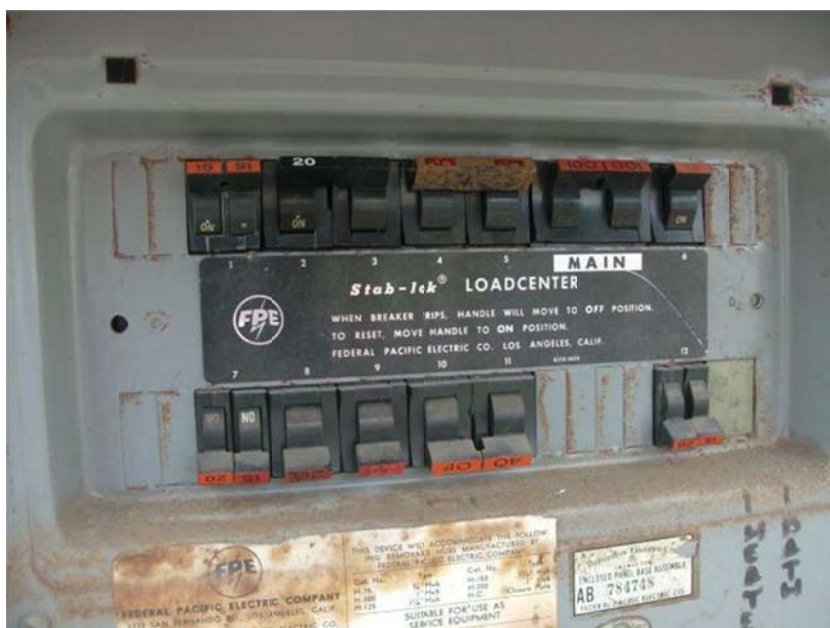
[SC] This electrical panel was manufactured by Federal Pacific / Stab-Lok. **Opinions of electrical professionals vary on the need to replace or upgrade these panels.** These panels have been known to present latent hazards by malfunctioning or jammed circuit breakers under certain conditions and may not trip (disconnect the power). Failure can also occur at the connections to the bus bars due to inadequate bending space for the service entrance conductors.

Based on the above information and in the interests of safety we recommend our clients consult with a qualified electrician and discuss the replacement of these panels.
