Zinsco or Sylvania-Zinsco Electrical Equipment Hazards

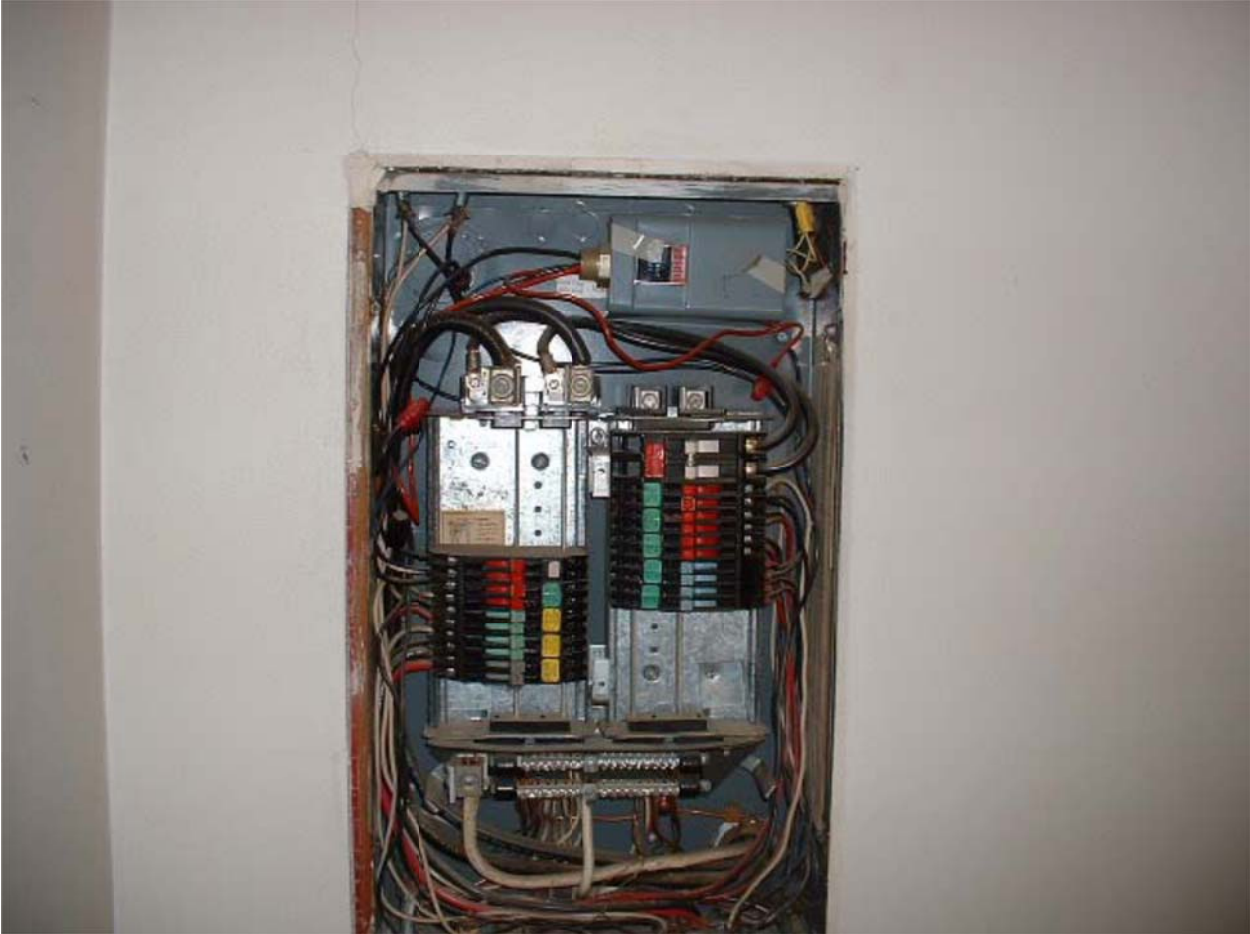
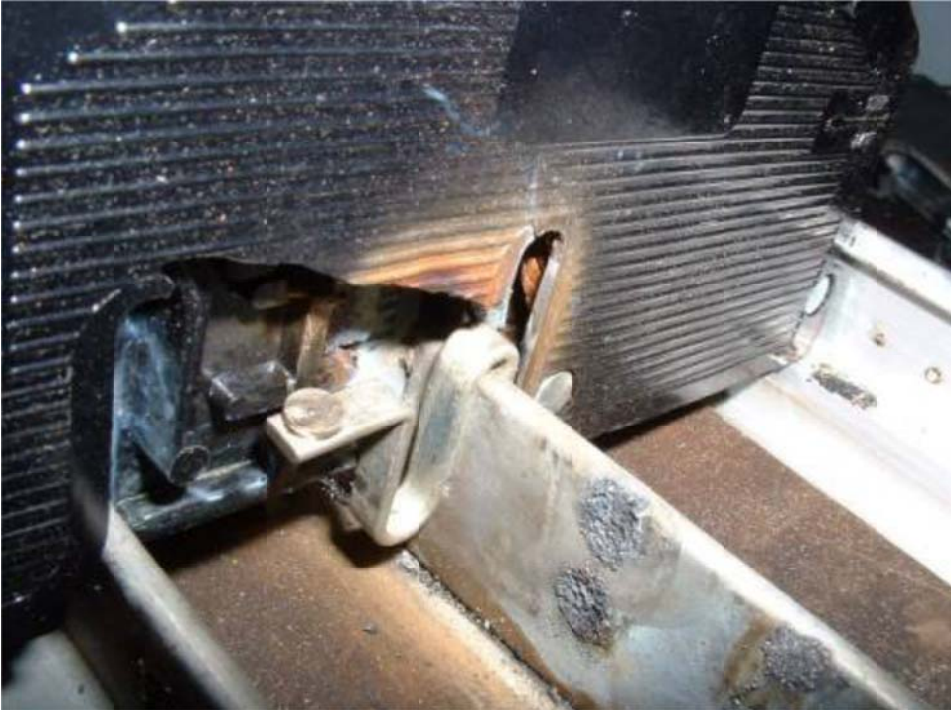
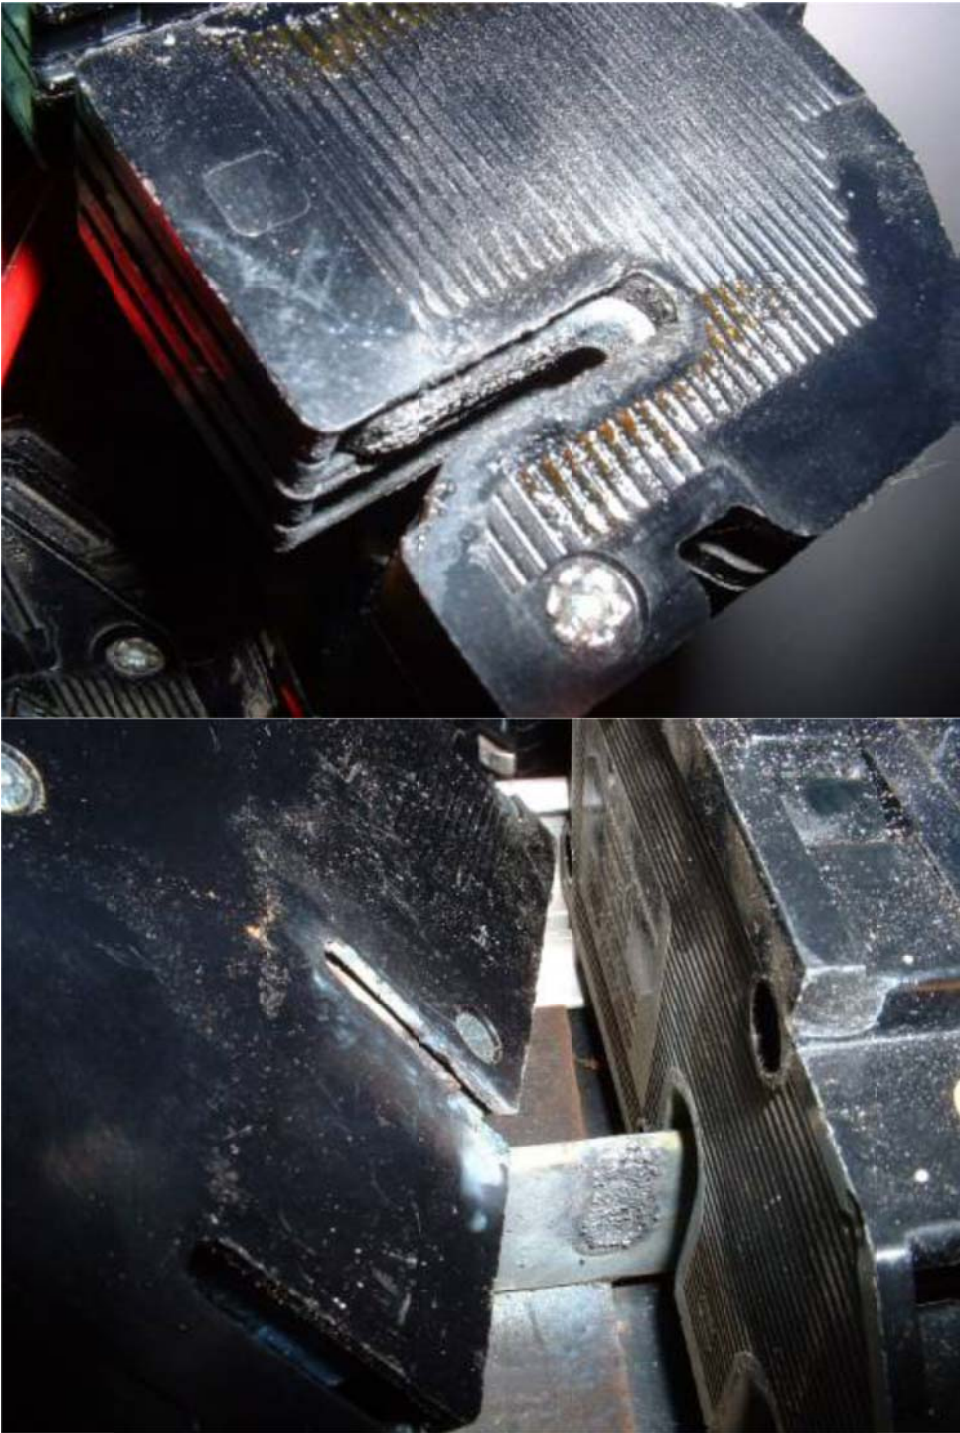
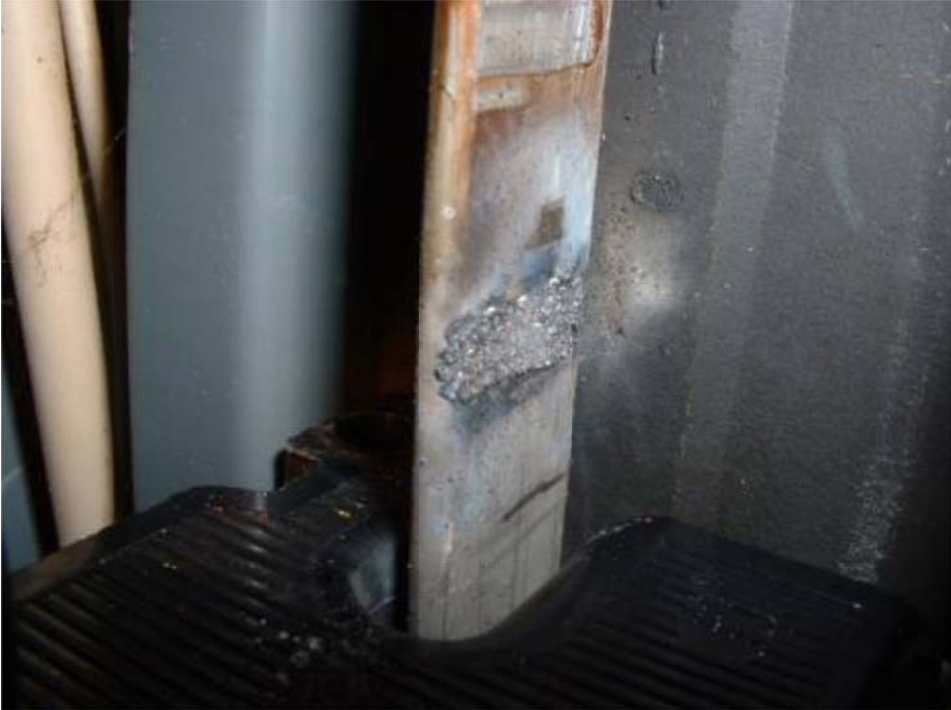
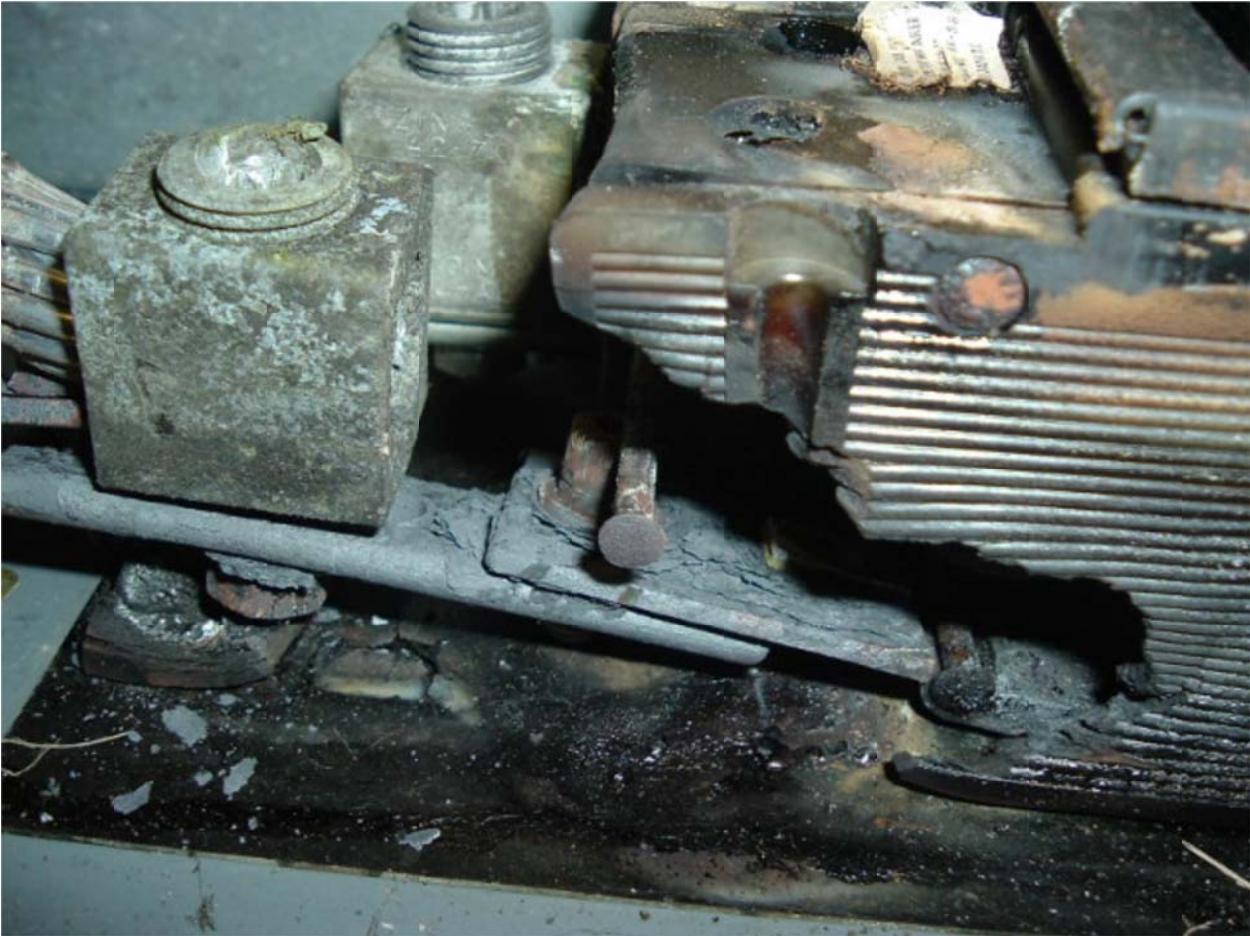
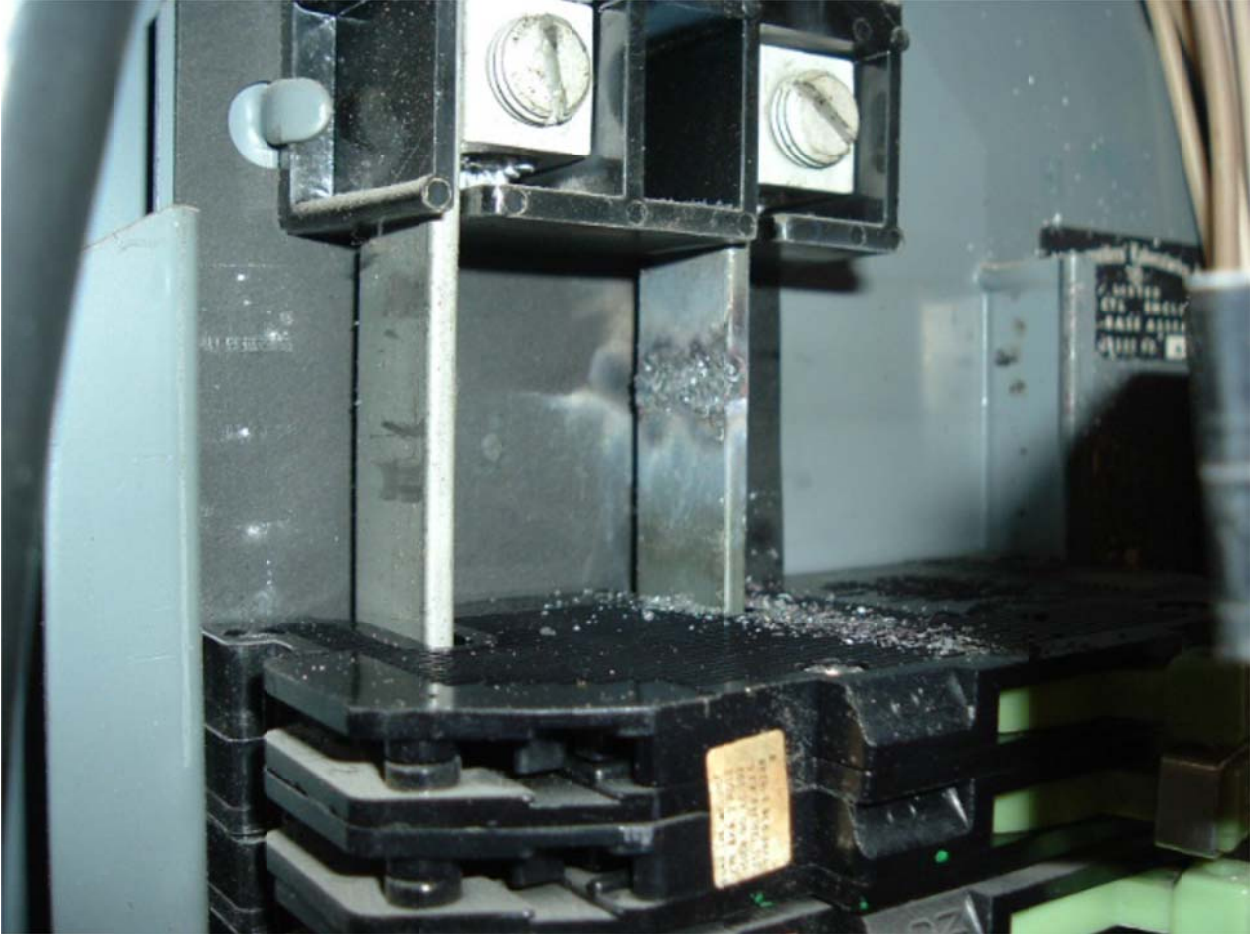
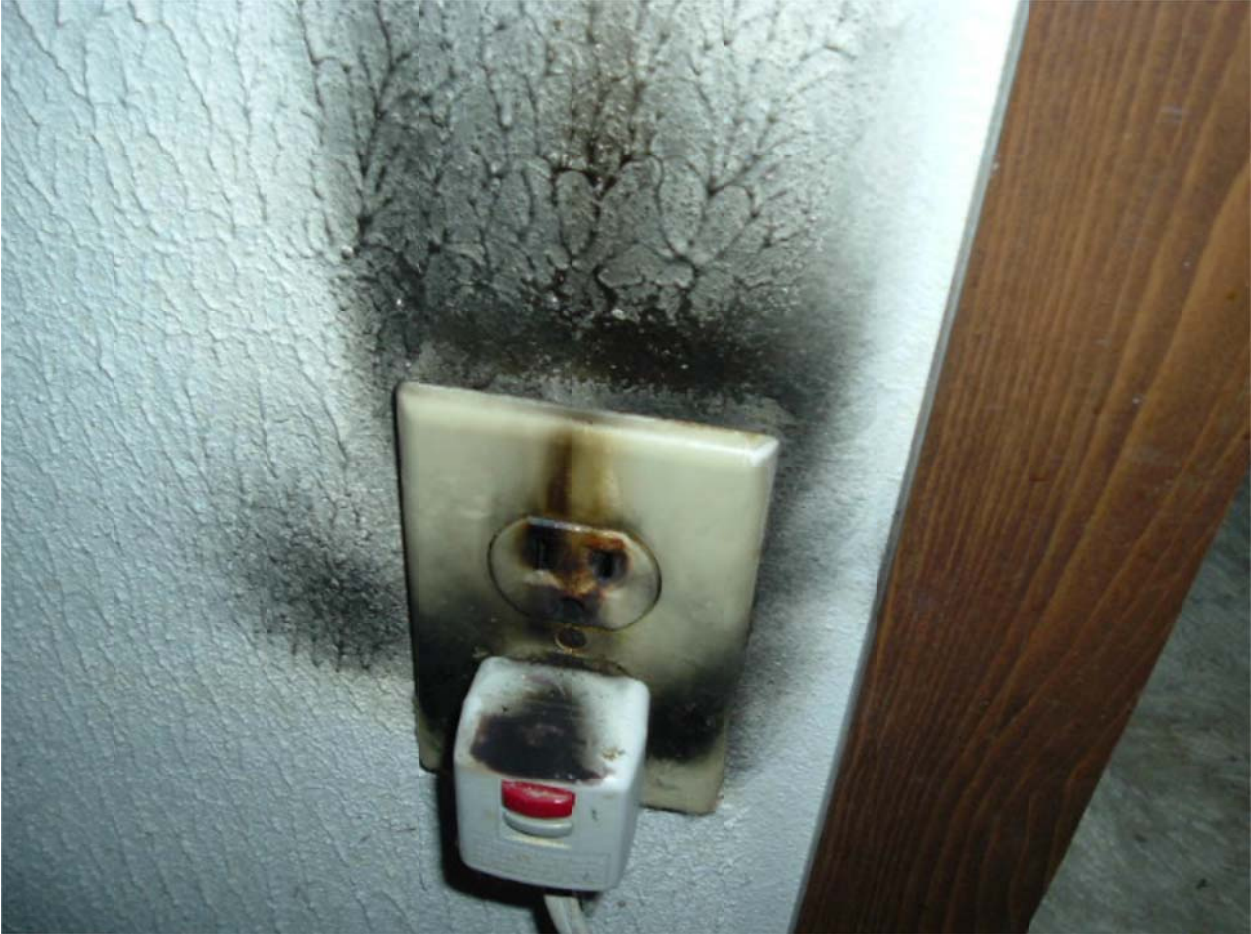
Damage is found in about 25% of the Zinsco/Sylvania panels that are checked. The problem occurs mostly on circuit breakers feeding circuits that have a steady heavy load on them (like heaters, hot water tanks, dryers), and on circuits that are often overloaded such as circuits that supply the kitchen or bathroom.

- Arcing and/or overheating, or a similar failure process occurs at the connection of the circuit breaker to the electrical panel bus damage the bus, the breaker, and the connection, making the electrical contact unreliable and leading to equipment failure.
- Circuit breakers become damaged by arcing or overheating. Damaged circuit breakers are unlikely to perform properly in response to an overcurrent condition.
- Aluminum electrical panel components appear to be an important factor in failures in this equipment
- Moisture exposure appears to be a factor in failures in this equipment.

- Circuit breakers may fail to trip in response to an overcurrent condition. This is a fire and shock risk.
- Circuit breakers may "blow out" the side casing of the device in an electrical "arc explosion."
- Circuit breakers may fail to drop power even when they are switched off - that is, the breaker may appear to be switched to the "off" position but internally it may still be conducting power to the circuit.

Below are some photos of Zinsco/Sylvania Panels
