Hazards of Uncoated Brass Flexible Gas Connectors in Older Homes

CAUTION! *Certain older gas connectors may be dangerous.*

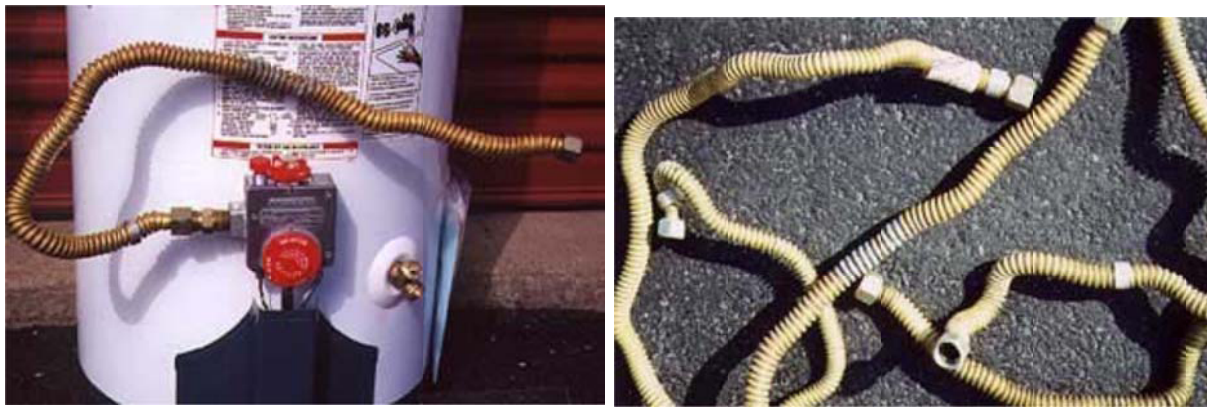
These older brass connectors have a serious flaw in how their tubing was joined to their end pieces. Over time, the end pieces can separate from the tubing, and cause a serious gas leak, explosion, or fire. To our knowledge, these dangerous uncoated brass connectors have not been made for more than 20 years, but many of them are still in use. The older these connectors get, the greater the possibility of failure.

These brass gas-flex connectors were installed in older homes (pre 1976) These types of connectors are responsible for several failures. These connectors are used on water heaters, furnaces, clothes dryers and stoves. They are uncoated brass and will fracture if left in place.

Although not all uncoated connectors have this flaw, it is very difficult to tell which ones do. Therefore, any uncoated brass connector should be replaced immediately with a new stainless steel connector. Connectors can wear out from too much moving, bending or corrosion. Connectors should always be replaced whenever the appliance is replaced or moved from its location.

Immediate Replacement Recommended.
